NATIONAL PROGRAM FOR INSPECTION OF NON-FEDERAL DAMS
SUCKER BROOK DAM (VT. (U) CORPS OF ENGINEERS WALTHAM MA
NEW ENGLAND DIV FEB 80

SUCKER BROOK DAM

VT 00212

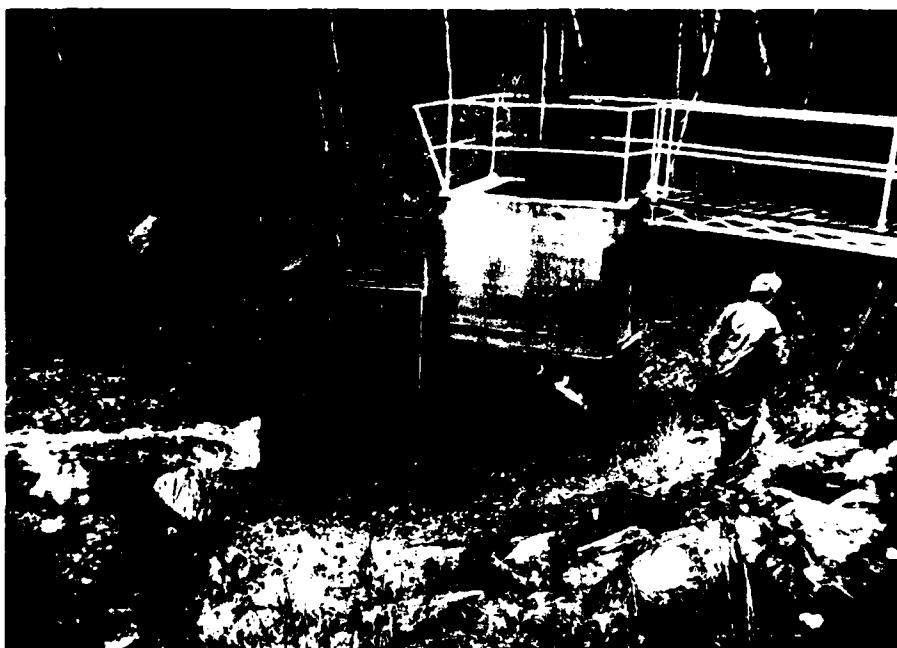
From what was readily visible, the intake structure and wooden trash rack are in fair to good condition. As seen in Photo C-7A, leaves and trash had collected against the rack structure and were causing some flow obstruction. The low water level and the partially exposed reservoir bottom, that appears like a bog, aggravate this condition. The inclined steel trash rack shown directly over the intake by the design/construction drawings (see Appendix B3-8) was not noted during the inspection.

C-7A Intake structure and control tower - 11/07/79
